Ranking of Cylinder Liner Materials in Two Stroke Marine Diesel Engines

Published in:
Proceedings of the International Conference BALTTTRIB'2009

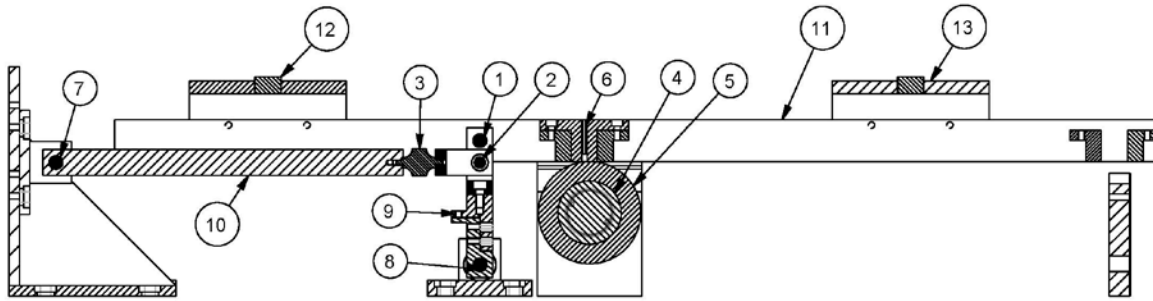
Figure 1. Shows a cross section of the test apparatus. The illustration is taken from the CAD files composed during the development process.

Figure 1. Schematic of the test apparatus. It is seen from the side and as a cross section.

Table 1. Description of the test apparatus as shown in figure 3.

Number:	Description:	Number:	Description:
1	Pivot point for the bridge	8	Pivot point for lower support
2	Pivot point for the force transducer	9	Adjustment screw for adjusting the height of the bridge
3	Force transducer (HBM U9B (0,5 kN))	10	The force transducer's connecting rod
4	Shaft holding test ring and connected to the electrical motor	11	Bridge
5	Test ring made of cylinder liner material	12	Counter weight sledge
6	Hole for the thermocouple. Measure the temperature in the contact line.	13	Loading sledge
7	Pivot point for the force transducers connecting rod.	-	-

Table 1 gives a schematic description of the test apparatus. Only the main components of the test apparatus are shown here. Whereas, other features and capabilities are as follows. The generated friction from the contact between the piston ring block and cylinder liner ring is measured with a force transducer. The oil film thickness is measured with two inductive sensors. The temperature in the contact line/oil temperature is measured with a thermocouple mounted in the bracket for mounting the piston ring block. All signals are collected with a NI-9219 card mounted in a NI-cDAQ 9172 chassis which is connected to a PC by a USB wire. The motor's speed in rpm is measured direct from the motor through a RS232 connection to a PC. The system is sampling synchronous from all channels.

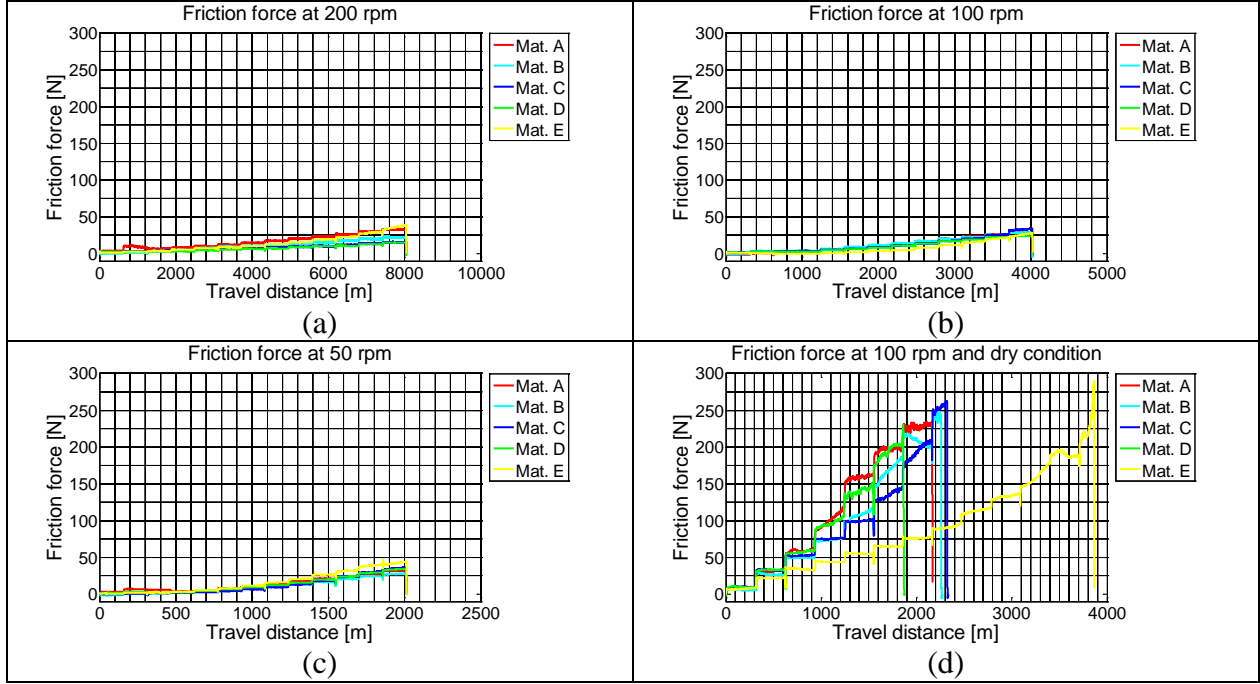
Figure 2. Friction forces measured at 200 rpm (a), 100 rpm (b), 50 rpm (c) and 100 rpm dry contact (d) with ground specimens.

Figure 2. (a), (b) and (c) presents the friction forces obtained at 200, 100 and 50 rpm and oil added for the five materials. No discrepancy between the friction forces measured at the different speeds or materials is clear. The friction forces at the end of the experiments are all in the interval 30 to 40 N which is considered to be the same due to uncertainties.

By evaluating the graphs in figure 2 (d) showing the friction forces measured with dry contact it is clear that material E is fundamentally different from the four other materials¹. The friction force measured with material E is from the travel distance 0 to 500 meters around the same as for material A to D, but from 500 meters and onwards material E starts to deviate significantly from the other materials. Material E runs for a longer distance (roughly computed 1.75 times longer) than the others. This means, that seizure does not occur with material E in the same scale as with material A to D. Material B and C stand out from material A and D. Material A and D are running for a longer distance and achieving lower friction forces for the same load steps. Material D exhibits the worst behaviour of all the tested materials. Material D runs for only 1.875 meters which indicates that this material is more exposed to seizure when running under dry condition compared to the other materials.

By comparing figure 2(a), (b) and (c), with ground/burnished surfaces, with figure 5 (a), (b) and (c), with rough surfaces, a significant difference in measured friction forces is observed. With the ground/burnished surfaces the friction forces are in the interval 30 to 40 N and with rough surfaces the friction forces are fluctuating around 125 N. This is an increase in the friction forces of a factor of 3 to 5 from ground/burnished surfaces to rough surfaces. This clearly stresses the importance of the surfaces topology. It also stresses the importance of having similarly manufactured components when the materials are ranked with the method developed.

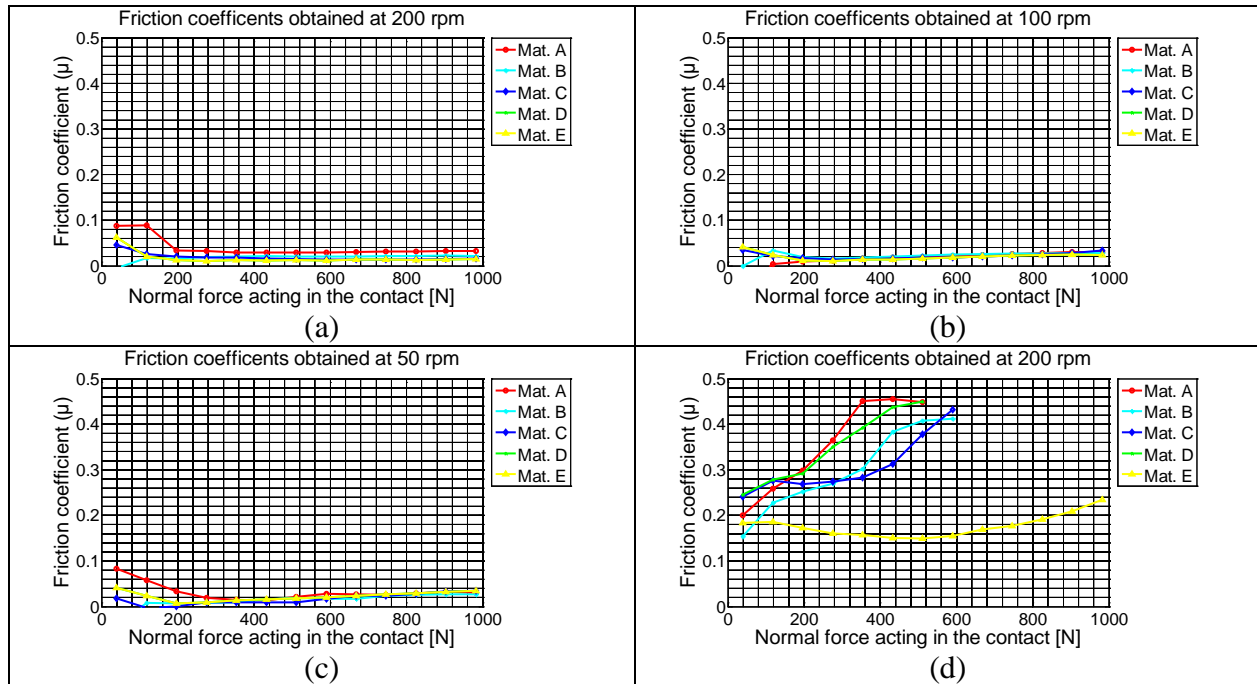
Figure 3. Graphs representing the friction coefficients obtained at 200 rpm (a), 100 rpm (b), 50 rpm (c) and 100 rpm dry contact (d).

In figure 3, the graphs are representing the calculated friction coefficients for the experiments run with ground/burnished cylinder liners ring and piston ring segment. The first three points (interval from 40 to 200N) in figure 3(a), (b) and (c) have to be discarded due to the uncertainties in the measurement. From 200N and onwards the graphs are correct. When figures 3(a), (b) and (c) are compared it becomes clear that the friction coefficients at 50rpm increases steadier than those at 200 and 100rpm. This indicates a higher contribution from hard asperity contacts. From 200N and onwards the friction coefficients are in

the interval from 0.01 to 0.03 and these values are considered to be realistic and the five materials are stated to performing equally under lubricated conditions. Presented in figure 3(d) are the graphs for the experiment done at dry running conditions. Under dry conditions the materials differ from each other regarding seizure and thereby friction coefficients which is already established by the explained differences in the measured friction forces. It can be seen in figure 3(d) that material E has a friction coefficient which is up to a factor of 3 lower than for the rest. This is, however, only the case under dry running conditions. When an oil film is present (figure 3. (a), (b) and (c)) the friction coefficients are all the same for the five materials.

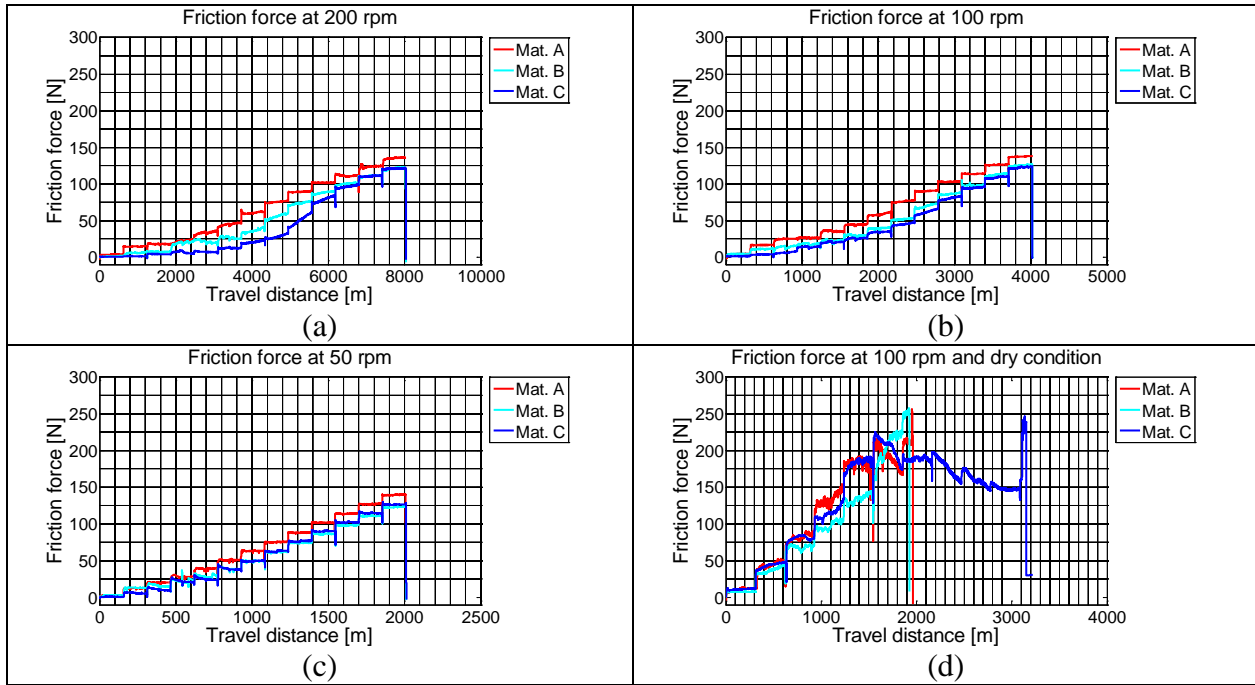
Figure 5 shows the change in the friction forces as the load is increased. Graphs (a), (b) and (c) represent the experiments performed with a lubricated contact between the cylinder liner ring and the piston ring block. There is no significant difference in the three materials performance when oil is present in the contact line and the surfaces are rough. This is equivalent to what was established out from Fig. 2 (a), (b) and (c). The graphs end on approximately 125 N in case (a), (b) and (c). The small deviations between the graphs are ascribed to the variation in amount of oil available in the contact line.

Figure 5. Friction forces measured at 200 rpm (a), 100 rpm (b), 50 rpm (c) and 100 rpm dry contact (d).

The experiments with dry contact between the components are continued until the electrical motor's integrated safety system cuts off the power to the motor due to overload. Figure 5(d) shows the friction forces measured in the case where the components are in dry contact and with rough surfaces. Materials A and C are travelling the same distance. Material C runs for approximately 1.100m more than material A and B. This is due to oil from the construction oozed down on the cylinder ring and thereby destroyed the experiment. The results for material C should therefore be ignored. Probably the pollution started at approximately 1.550m where the curve for the friction force starts to decrease.

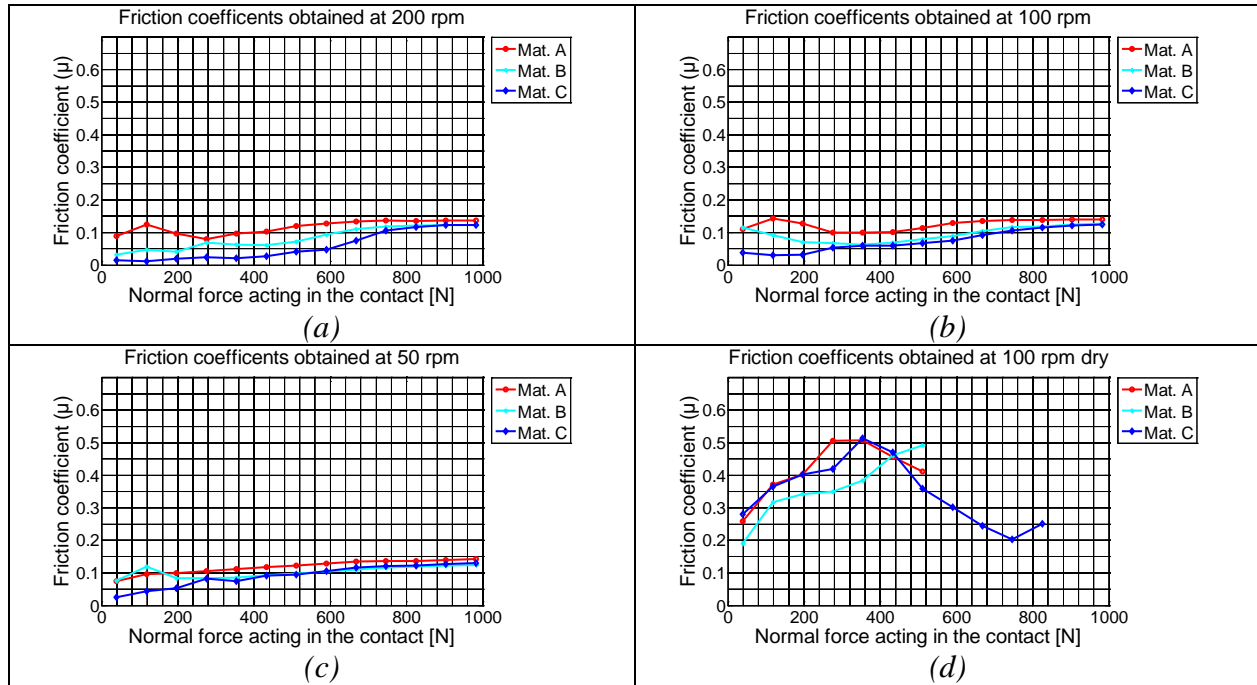
Figure 6 presents the friction coefficients calculated on the basis of the measured friction forces and the load step in question. The graphs a, b and c show that material A has the highest friction coefficient. The graphs also show that the friction coefficients are rising throughout the experiments. This indicates influence from asperity contact which means that the oil film thickness is not sufficient to separate the surfaces. The increase in the friction coefficients are larger than those calculated for the ground/burnished surfaces. Since the roughness is smaller for the ground surfaces the required oil film thickness to separate the surfaces is smaller. The friction coefficients for the three materials are in the interval from 0.05 to 0.15. Figure 6(d) presents the friction coefficients from the experiment run with dry contact between the piston ring block and cylinder liner ring and rough surfaces. This graph clearly shows that material B is performing better than material A. Material C is also performing worse than material B from a normal force of 40 N to 350 N but this observation should be made with care due to the oil pollution of the experiment mentioned earlier. The friction coefficients are in the interval from 0.2 to 0.5. This is equivalent to what was obtained with the ground/burnished surfaces.

Figure 6. Graphs representing the friction coefficients obtained at 200 rpm (a), 100 rpm (b), 50 rpm (c) and 100 rpm dry contact (d).

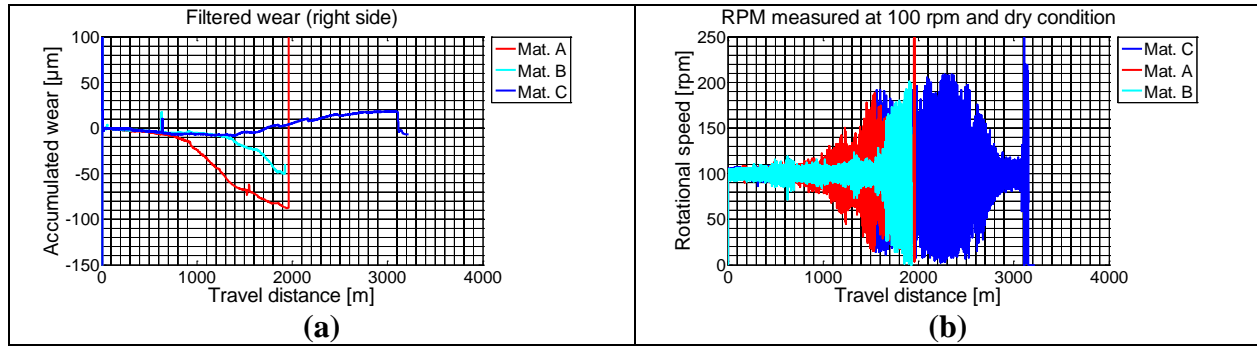
Figure 7(a) shows the accumulated wear measurement. This is a measure of how much both the piston ring block and cylinder liner ring are worn all together. The graphs can be utilized to get information regarding incubation time for the materials. Consistent with what is presented in Table 4 material A is worn the most. The new information is that material A also has the shortest incubation time compared to material B.

Figure 7. Graphs representing the combined measured wear of the piston ring block and cylinder liner (a) and the rotational speed of the cylinder liner ring (b).

Figure 7 (b) shows the rotational speeds of the cylinder liner rings measured during the experiments at 100 rpm and with dry contact between piston ring block and cylinder liner ring. The graph gives information about how seizure evolves. Material A experiences seizure earlier than material B which is consistent with the observation in figure 7(a) where B has a longer incubation time. What also can be observed is that material B has a faster increase of seizure which indicates the material has poor seizure resistance.
